UNITED STATES ENVIRONMENTAL PROTECTION AGENCY

Subject: Removal Site Evaluation for the Barry Bronze Bearing Company Site, City of Camden,  
Camden County, New Jersey

Site I.D. No.: NJC200400018

### **Photo Documentation Barry Bronze Bearing Company Site**

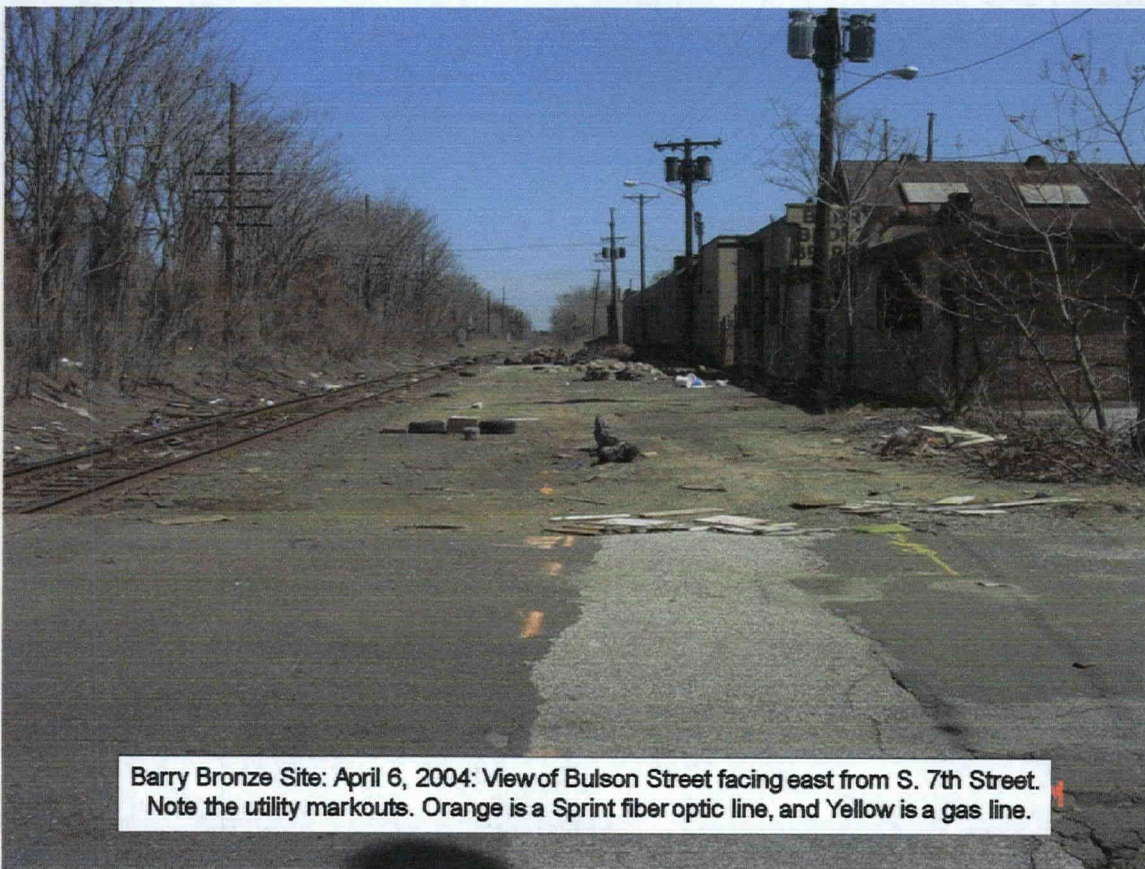
Barry Bronze Site: April 6, 2004: View of Bulson Street facing east from S. 7th Street. Note the utility markouts. Orange is a Sprint fiber optic line, and Yellow is a gas line.
